Progress with Licence Termination (Delicensing) of the UKAEA, Harwell Site, UK

Paul Atyeo

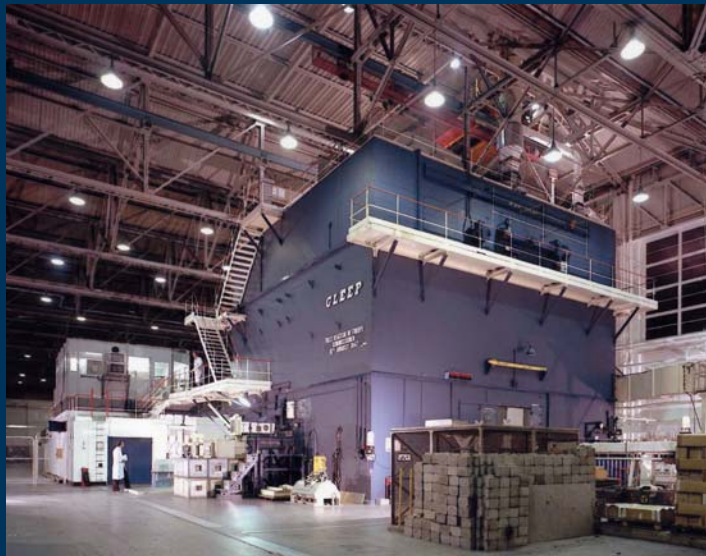
GLEEP Reactor

- Built mid-1940's, operated Aug 1947 to Sept 1990
- Thermal heterogeneous reactor, graphite moderated/reflected, air cooled, natural Uranium metal fuel.

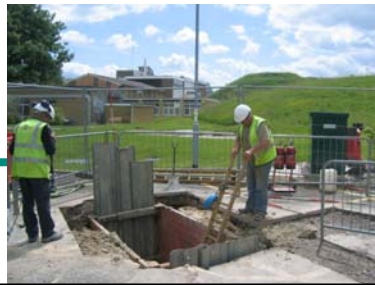
Trade Waste Drains

- TWD on Harwell site is being decommissioned
 - Pressure washed
 - CCTV inspected
 - Faults and unknown sections to be removed
 - Gamma survey
 - grouted
- All drain sections exceeding delicensing criteria will be removed
